Project Name: AMEY 3076	Project number: 3076	Date: 05/08/2015	Contact: David Coombs, Amey
----------------------------	-------------------------	---------------------	--------------------------------

Place : BLAISDON, LONGHOPE	Road : BLAISDON VILLAGE ROAD	Date : 05/08/2015	Section number : 1	PLR Suffix : X
--------------------------------------	--	-----------------------------	------------------------------	--------------------------

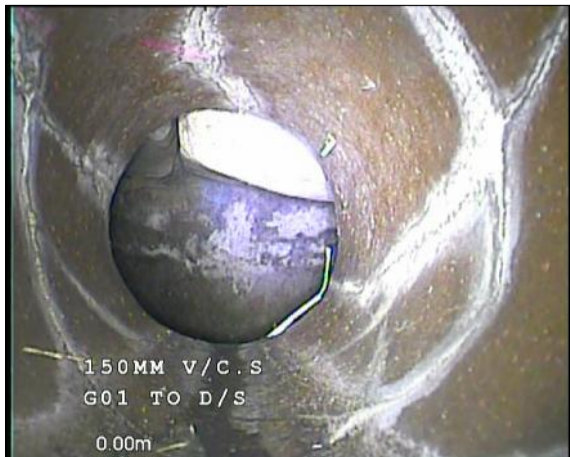
Photo: 1_1_32_A.jpg, 00:00:05
 0m, Cracks, multiple, from 12 to 12 o'clock

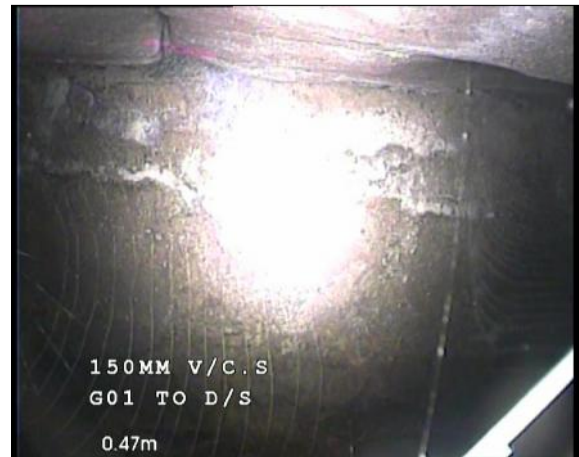
Photo: 1_1_33_A.jpg, 00:00:22
 0.5m, Finish node type, other special chamber reference
 number: D/S Remarks: CONNECTION ONTO STONE
 CULVERT

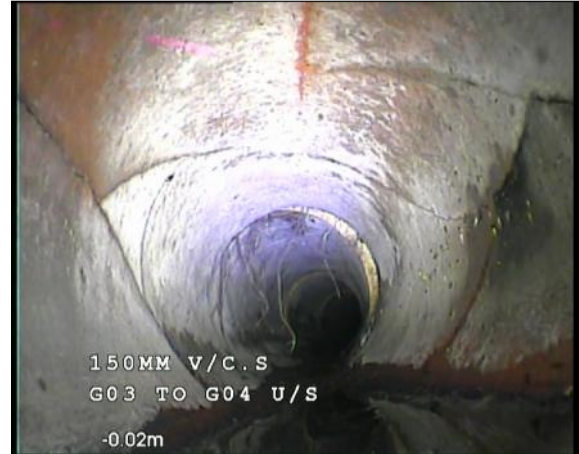
Photo: 5_5_52_A.jpg, 00:00:07
 0m, Cracks, multiple, from 12 to 12 o'clock

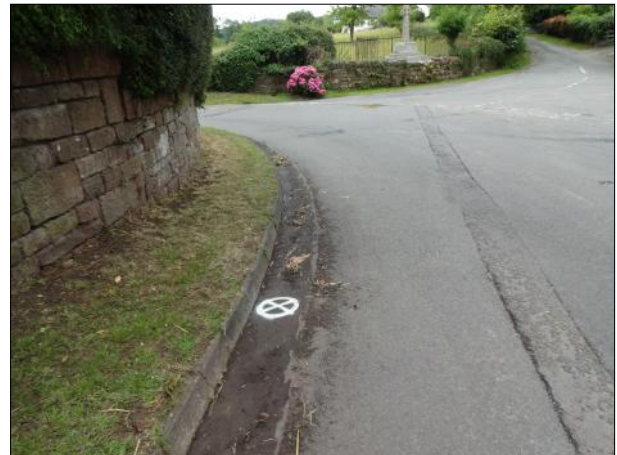
Photo: DSC02038.JPG, 00:01:07
4.6m, Survey abandoned Remarks: UNABLE TO CONTINUE.
OBSTRUCTION TRACED & MARKED AT 10MTS 0.85MTS
DEEP

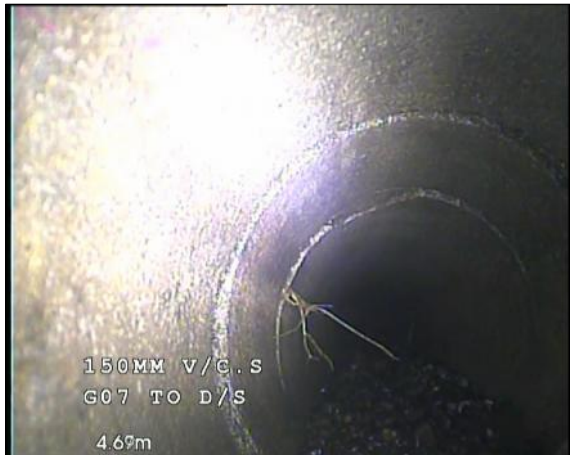
Photo: 7_7_79_A.jpg, 00:00:42
 4.7m, Fracture, circumferential, from 9 to 3 o'clock

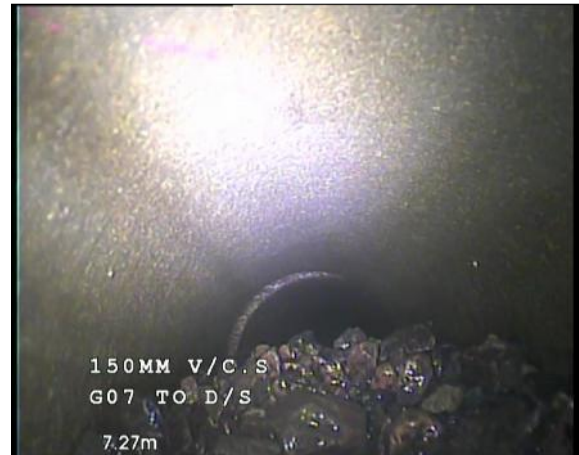
Photo: 7_7_82_A.jpg, 00:01:10
 7.2m, Settled deposits, coarse, 70% cross-sectional area loss

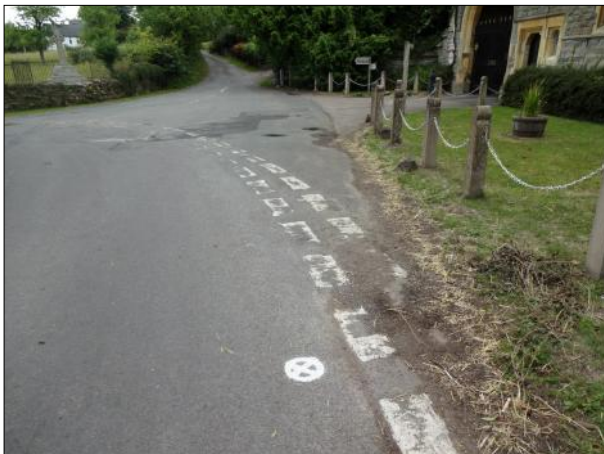
Photo: DSC02040.JPG, 00:01:10
 7.2m, Survey abandoned Remarks: UNABLE TO CONTINUE.
 OBSTRUCTION TRACED & MARKED AT 19MTS 0.86MTS DEEP

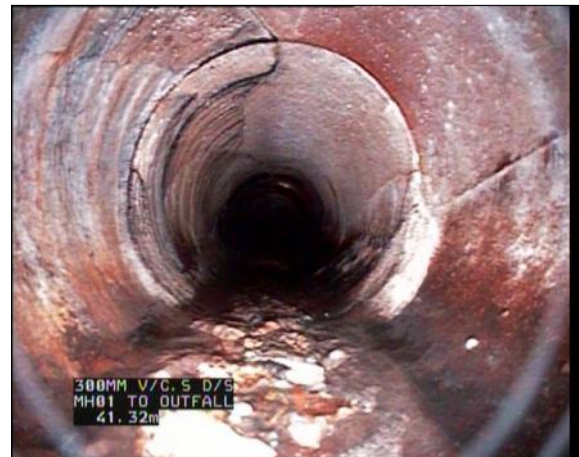
Photo: 12_12_129_A.jpg, 00:07:12
 41.3m, Cracks, multiple, from 8 to 4 o'clock

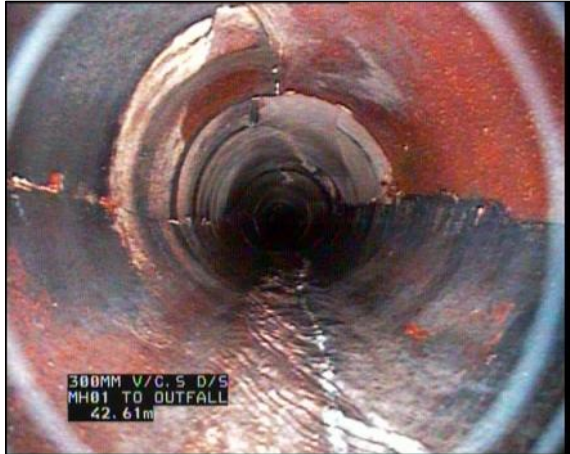
Photo: 12_12_131_A.jpg, 00:07:32
 42.6m, Fracture, multiple, from 12 to 12 o'clock, Start

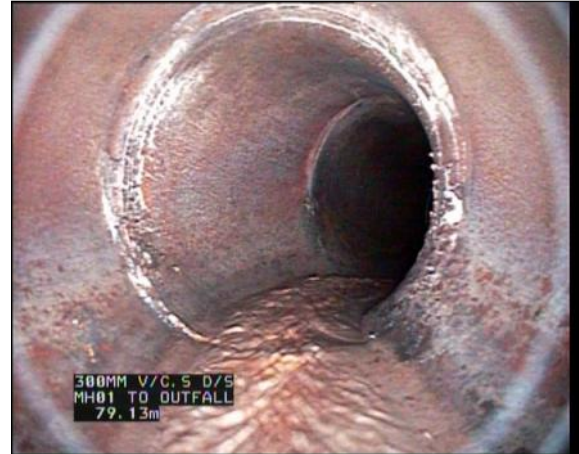
Photo: 12_12_144_A.jpg, 00:12:32
 79m, Line deviates right

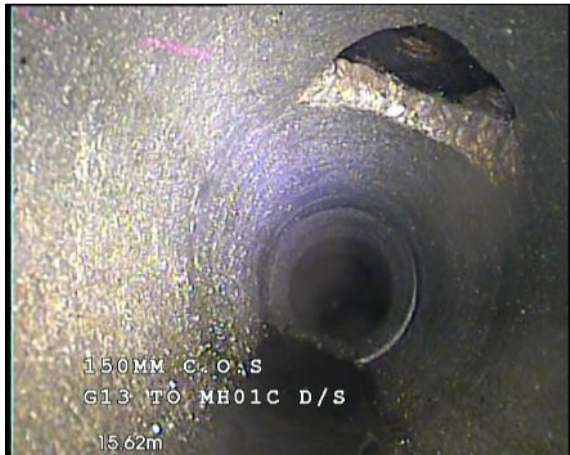
Photo: 22_22_254_A.jpg, 00:02:21
 15.6m, Hole in drain/sewer, from 11 to 1 o'clock Remarks:
 POSSIBLE POOR REPAIR

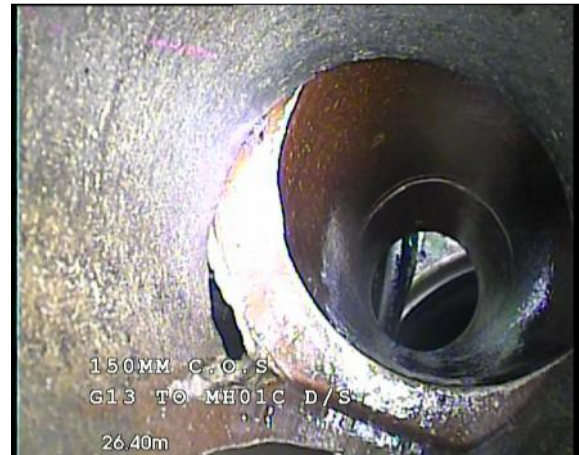
Photo: 22_22_262_A.jpg, 00:04:08
 26.4m, Survey abandoned Remarks: UNABLE TO PASS
 POOR JOINT. MH01C IN VIEW

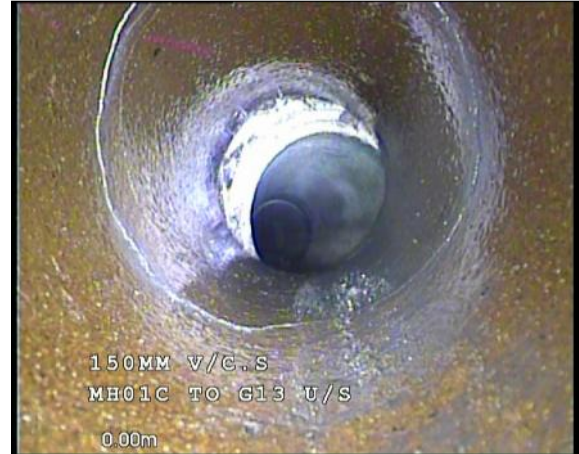
Photo: 24_24_272_A.jpg, 00:00:04
 0.1m, Crack, circumferential, from 12 to 12 o'clock

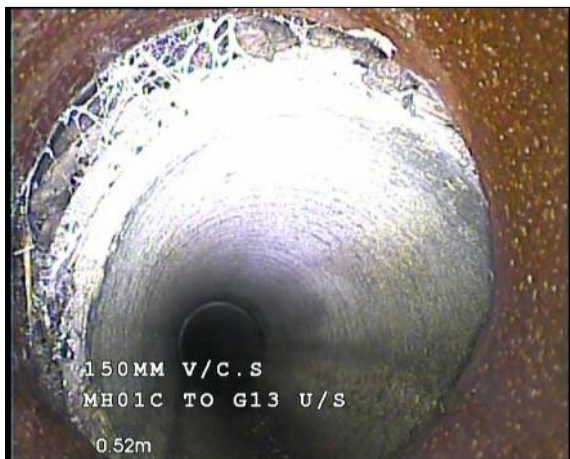
Photo: 24_24_275_A.jpg, 00:00:19
 0.5m, Survey abandoned Remarks: OVERLAP COMPLETE TO POOR JOINT

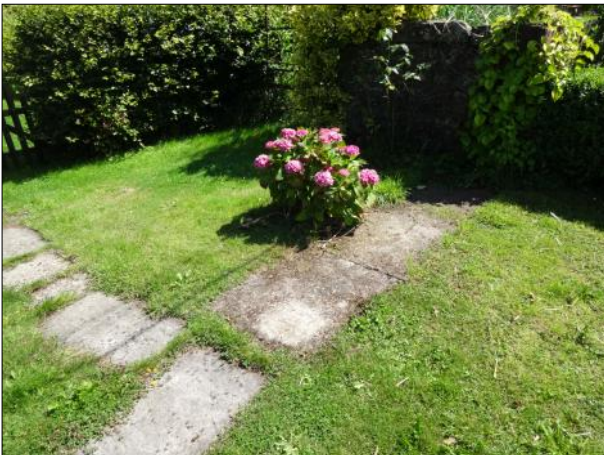
Photo: DSC02080.JPG
 0m, Start node type, manhole, reference number : 01D
 Remarks: UNABLE TO RAISE MH01D. LARGE CONCRETE SLAB ON DRIVE

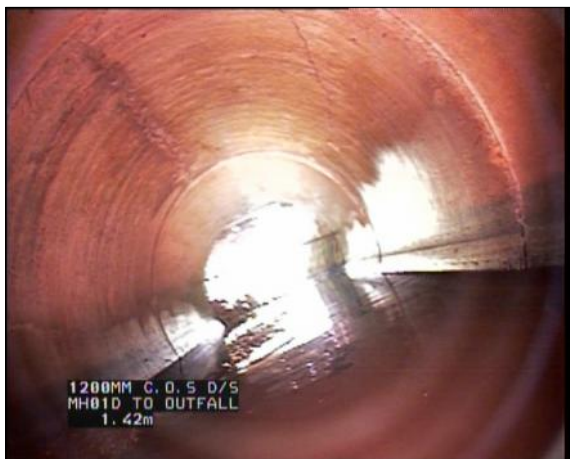
Photo: 27_27_297_A.jpg, 00:00:24
 1.4m, Crack, longitudinal, at 1 o'clock

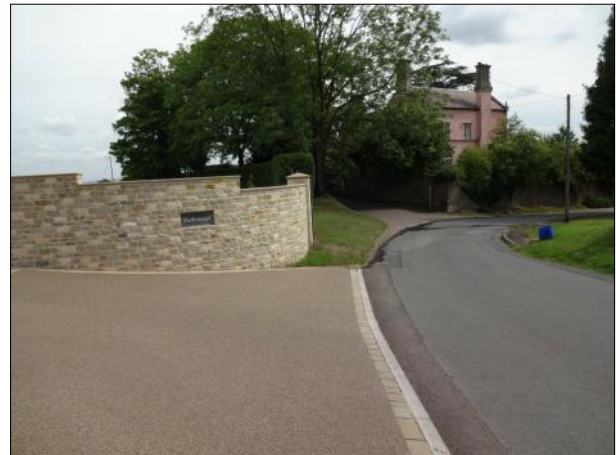
Photo: DSC02167.JPG, 00:00:58
 1.3m, General photograph taken at this point Remarks:
 SURFACE WATER RUNNING FROM PRIVATE DRIVE.
 ASSUMED COLLAPSED PIPE AHEAD

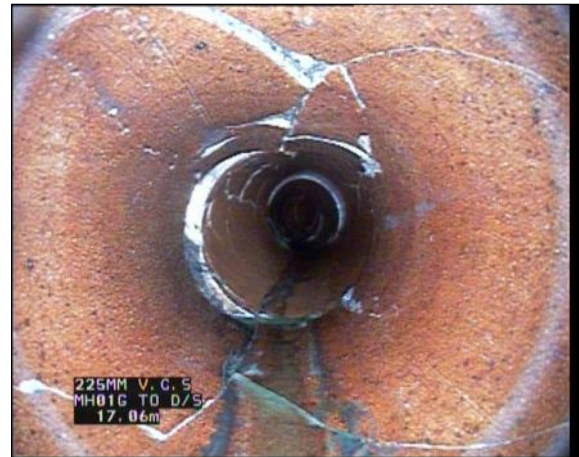
Photo: 33_33_377_A.jpg, 00:02:57
 17m, Fracture, multiple, from 12 to 12 o'clock

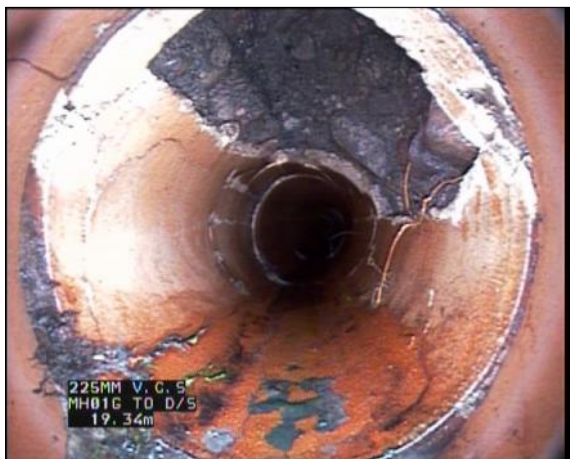
Photo: 33_33_379_A.jpg, 00:03:22
 19.3m, Hole in drain/sewer, from 10 to 3 o'clock Remarks:
 LARGE HOLE
