Project Name: AMEY 3076	Project number: 3076	Date: 05/08/2015	Contact: David Coombs, Amey
----------------------------	-------------------------	---------------------	--------------------------------

Place : BLAISDON, LONGHOPE	Road : BLAISDON VILLAGE ROAD	Date : 05/08/2015	Section number : 1	PLR Suffix : X
--------------------------------------	--	-----------------------------	------------------------------	--------------------------

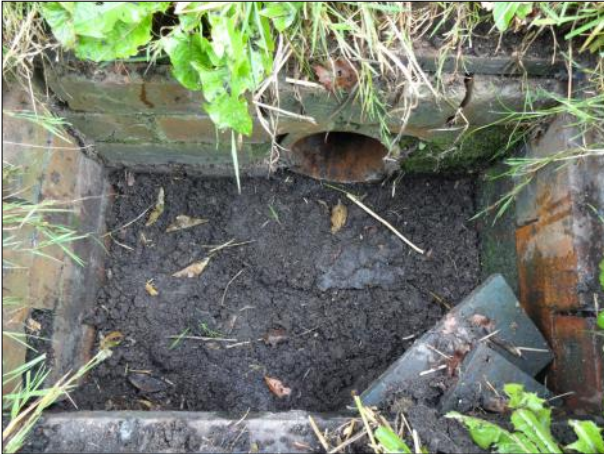
Photo: DSC02027.JPG
 0m, Start node type, gully, reference number : G01 Remarks:
 GULLY 01

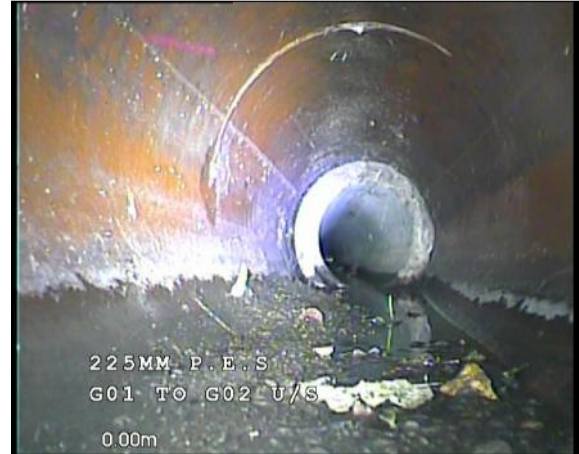
Photo: 3_3_35_A.jpg, 00:00:05
 0m, Settled deposits, fine, 05% cross-sectional area loss

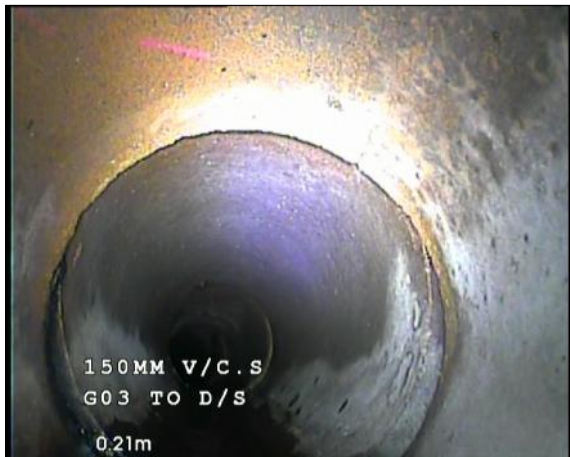
Photo: 4_4_44_A.jpg, 00:00:16
 0.3m, Joint displaced, medium, Start

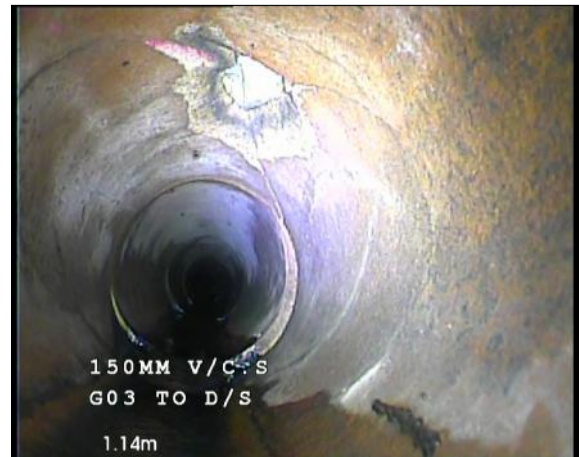
Photo: 4_4_47_A.jpg, 00:00:28
 1.1m, Hole in drain/sewer, at 1 o'clock Remarks: SMALL HOLE

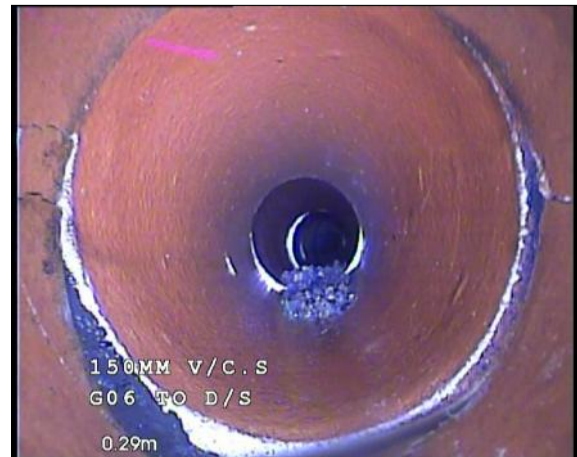
Photo: 6_6_64_A.jpg, 00:00:13
 0.3m, Joint displaced, medium, Start

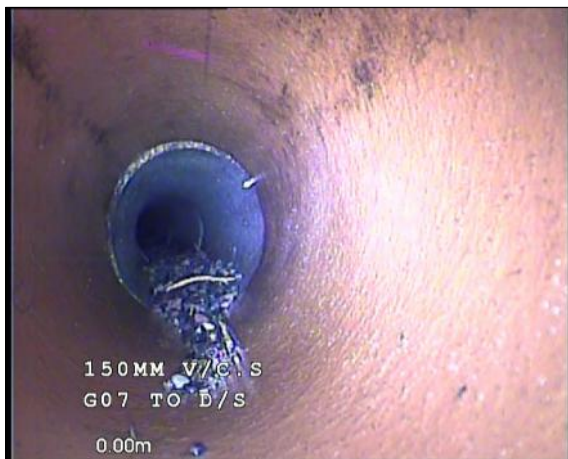
Photo: 7_7_15_A.jpg
 0m, General remark Remarks: HEAVY DEBRIS REMOVED.
 GULLY OPERATING POORLY

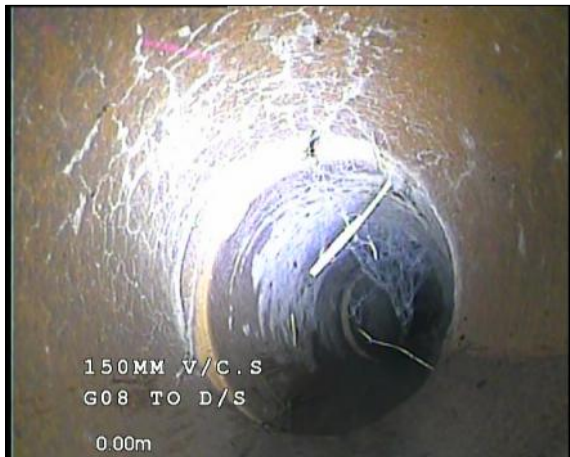
Photo: 8_8_85_A.jpg, 00:00:05
 0.3m, Joint displaced, medium

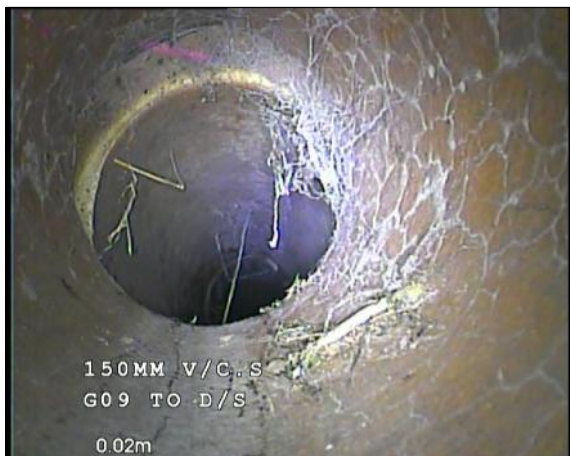
Photo: 9_9_93_A.jpg, 00:00:14
 0.3m, Joint displaced, medium, Start

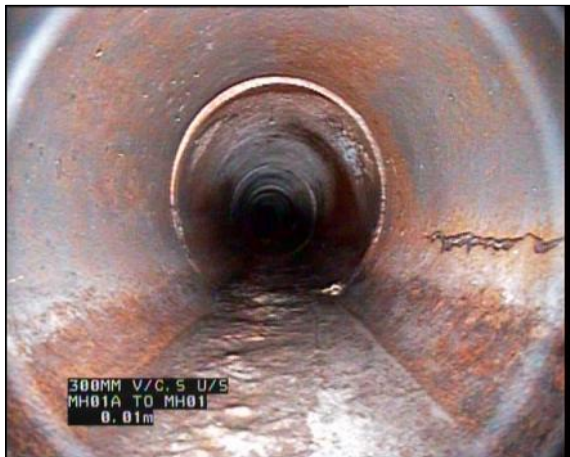
Photo: 11_11_23_A.jpg
 0m, Water level, 10% of the vertical dimension Remarks:
 HEAVY FOUL POLLUTION THROUGHOUT

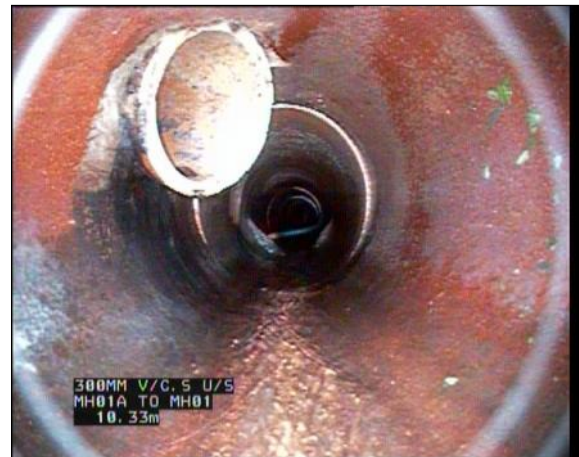
Photo: 11_11_103_A.jpg, 00:01:50
 10.3m, Connection intruding, at 10 o'clock, diameter 150mm,
 intrusion 10%

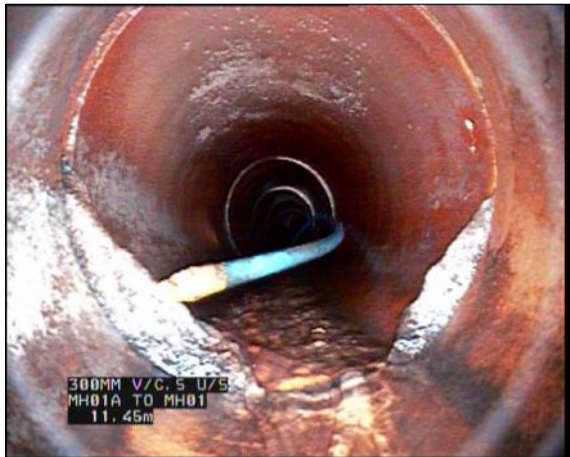
Photo: 11_11_106_A.jpg, 00:02:16
 11.4m, Attached deposits, other, at 6 o'clock, 5% cross-sectional area loss, Start Remarks: DRAIN RODS (REMOVED AFTER SURVEY)

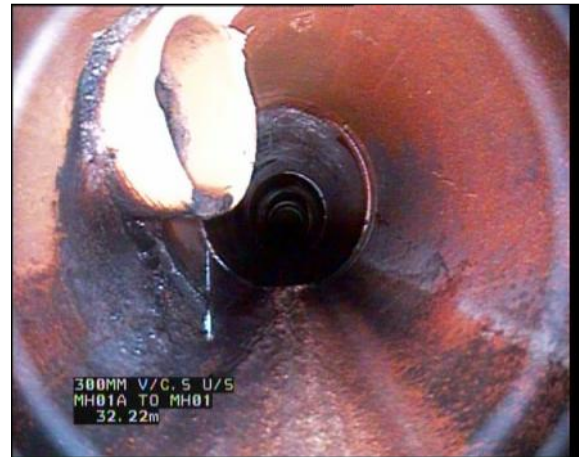
Photo: 11_11_113_A.jpg, 00:05:24
 32.2m, Survey abandoned Remarks: UNABLE TO PASS INTRUDING CONNECTION

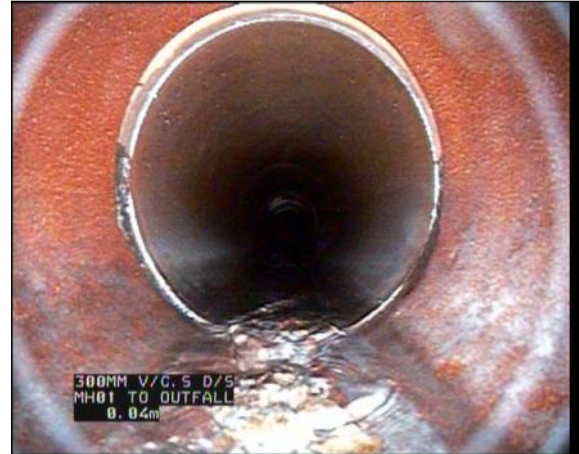
Photo: 12_12_28_A.jpg
 0m, Water level, 10% of the vertical dimension Remarks:
 HEAVY FOUL POLLUTION THROUGHTOUT

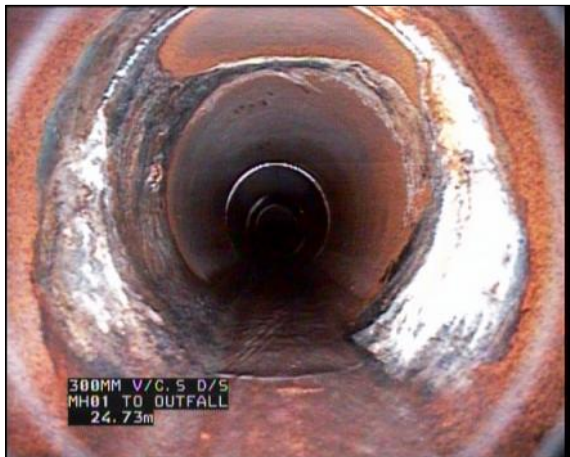
Photo: 12_12_122_A.jpg, 00:04:22
 24.7m, Attached deposits, encrustation at joint, from 7 to 5
 o'clock, 05% cross-sectional area loss

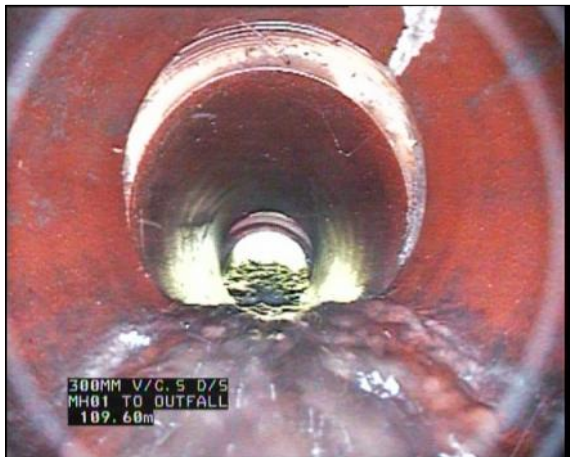
Photo: 12_12_149_A.jpg, 00:21:26
 109.6m, Line deviates down

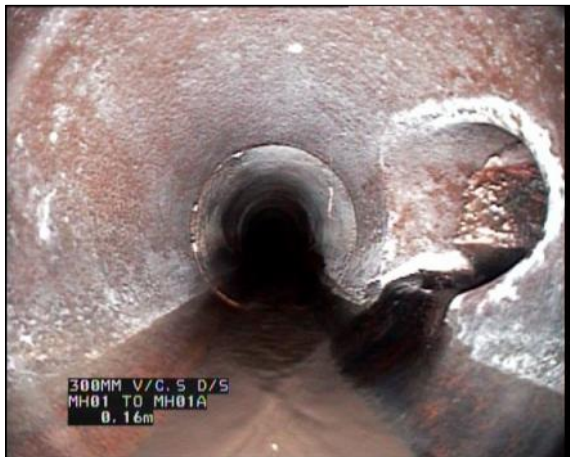
Photo: 13_13_30_A.jpg
 0m, Water level, 10% of the vertical dimension Remarks:
 HEAVY FOUL POLLUTION THROUGHOUT

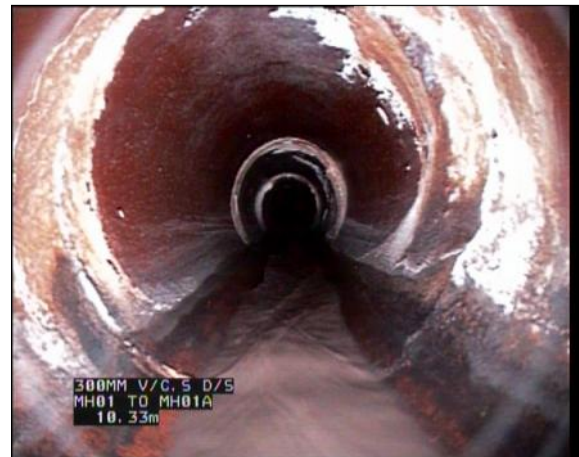
Photo: 13_13_158_A.jpg, 00:01:52
 10.3m, Attached deposits, encrustation at joint, from 7 to 5
 o'clock, 5% cross-sectional area loss, Start

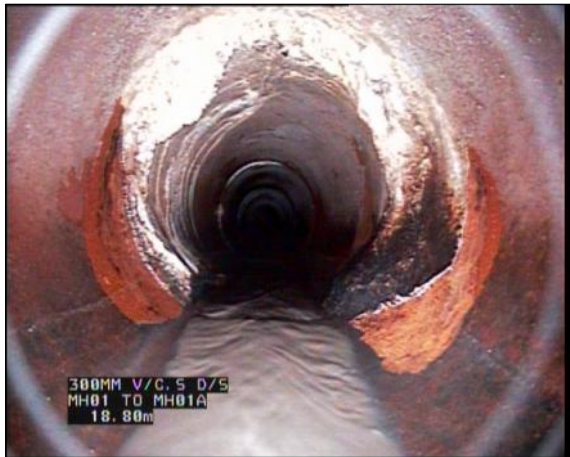
Photo: 13_13_162_A.jpg, 00:03:12
 18.8m, Attached deposits, encrustation at joint, from 7 to 5 o'clock, 10% cross-sectional area loss

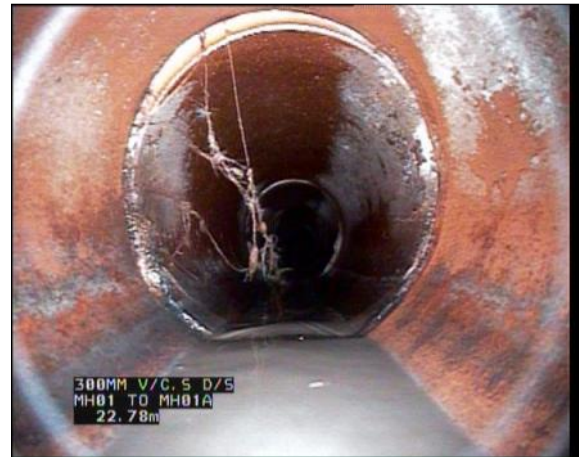
Photo: 13_13_166_A.jpg, 00:03:49
 22.7m, Roots, fine at joint

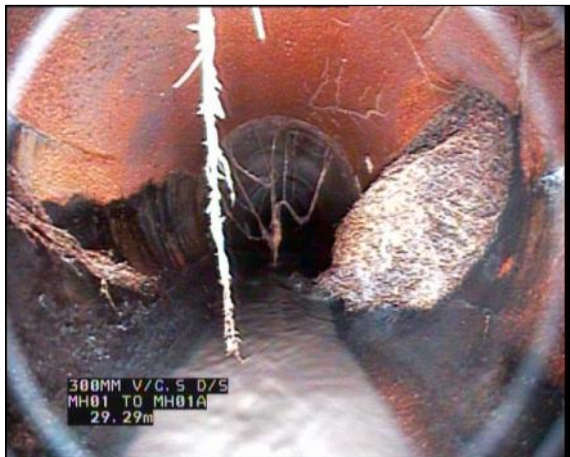
Photo: 13_13_169_A.jpg, 00:04:41
 29.3m, Roots, mass, 10% cross-sectional area loss Remarks: POSSIBLE REDUNDANT CONNECTION

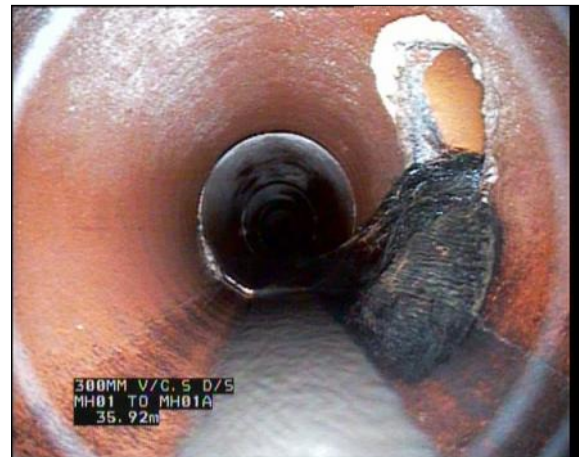
Photo: 13_13_170_A.jpg, 00:05:32
 36m, Connection other than junction, at 3 o'clock, diameter 150mm

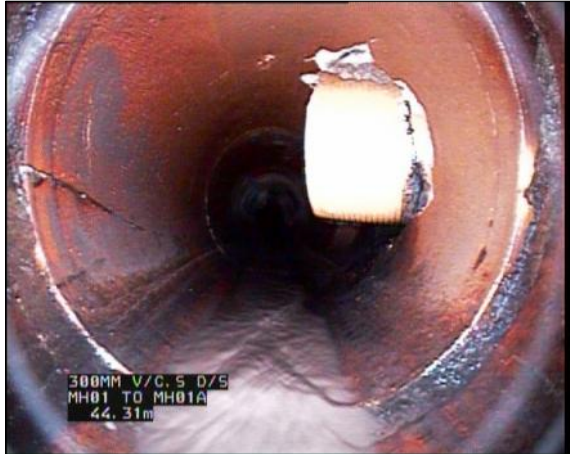
Photo: 13_13_177_A.jpg, 00:06:50
44.3m, Survey abandoned Remarks: OVERLAP COMPLETE
TO INTRUDING CONNECTION

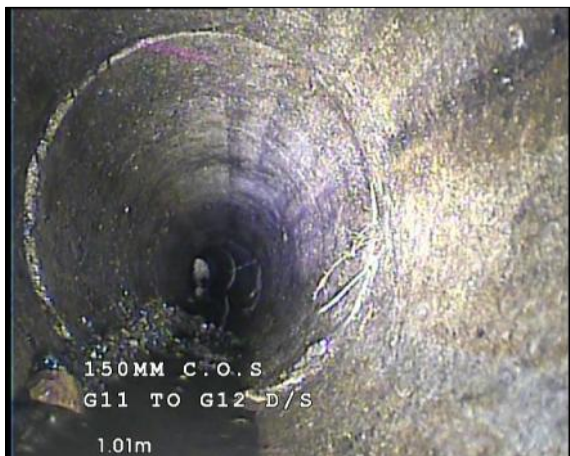
Photo: 15_15_212_A.jpg, 00:00:19
 1m, Roots, fine at joint, Start

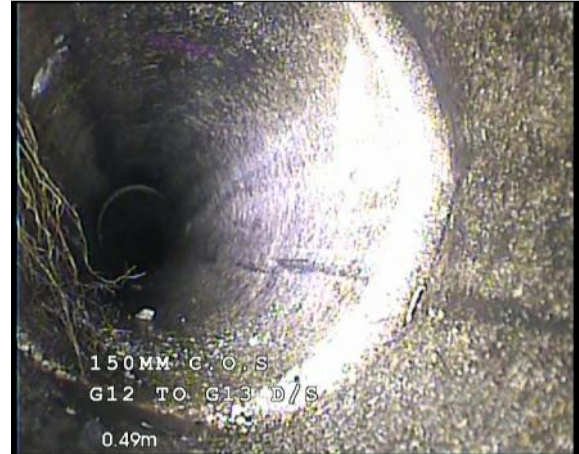
Photo: 16_16_218_A.jpg, 00:00:17
 0.5m, Roots, fine at joint, Start

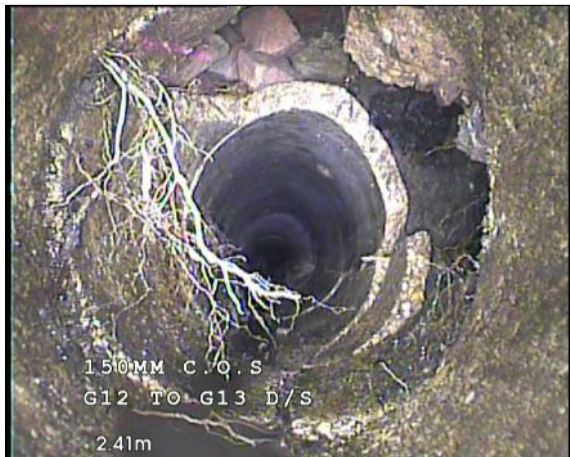
Photo: 16_16_219_A.jpg, 00:00:35
 2.4m, Hole in drain/sewer, from 10 to 5 o'clock Remarks:
 LARGE HOLE

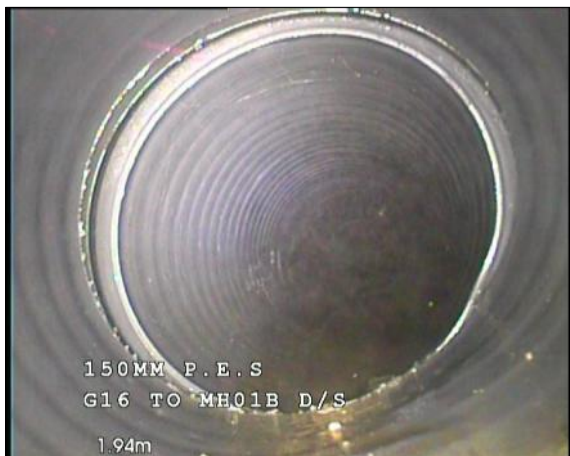
Photo: 19_19_235_A.jpg, 00:00:28
 2m, Deformed sewer/drain, 05%

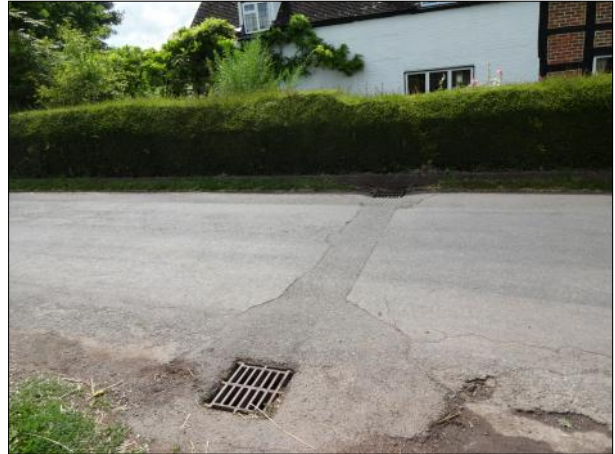
Photo: DSC02086.JPG
 0m, General photograph taken at this point Remarks:
 LOCATION PHOTO

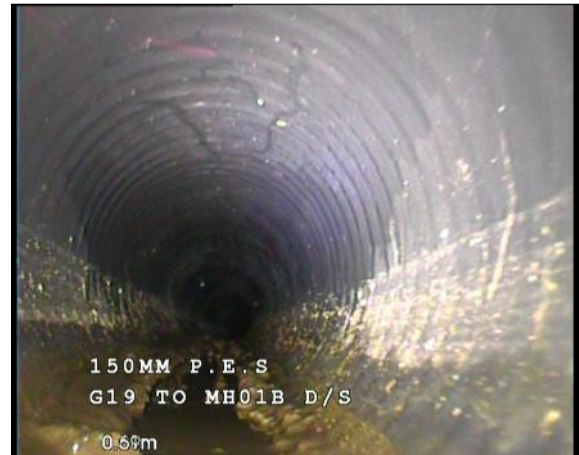
Photo: 21_21_240_A.jpg, 00:00:19
 0.6m, Settled deposits, fine, 05% cross-sectional area loss

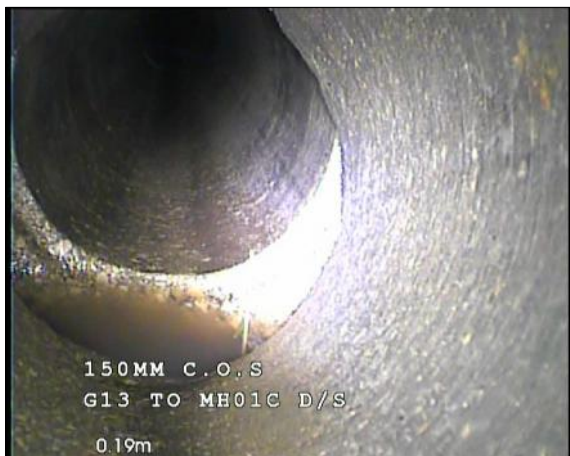
Photo: 22_22_244_A.jpg, 00:00:12
 0.3m, Joint displaced, medium

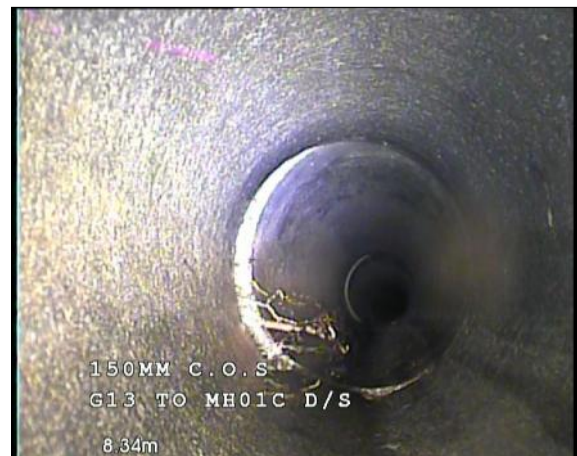
Photo: 22_22_246_A.jpg, 00:01:14
 8.3m, Roots, fine at joint

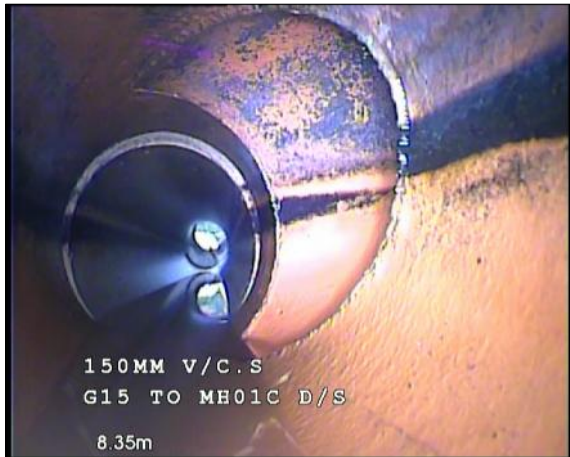
Photo: 23_23_265_A.jpg, 00:01:23
 8.3m, Junction, at 3 o'clock, diameter 150mm

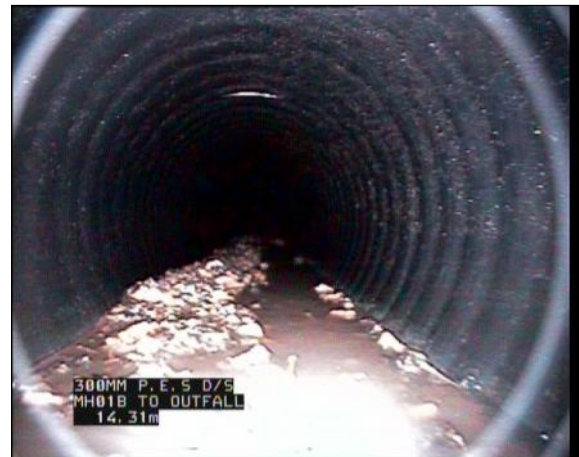
Photo: 25_25_278_A.jpg, 00:02:15
 14.3m, Settled deposits, fine, 10% cross-sectional area loss,
 Start

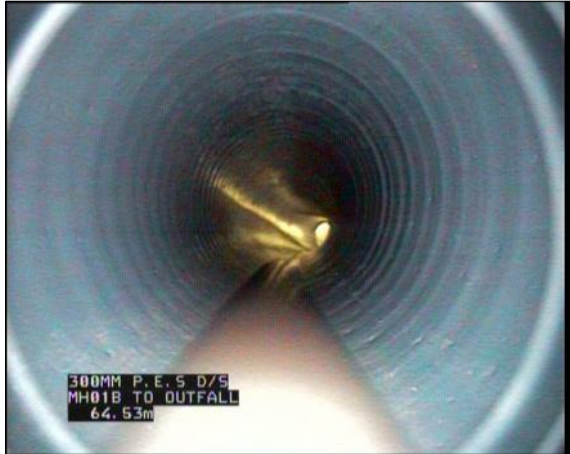
Photo: 25_25_284_A.jpg, 00:09:48
64.5m, Line deviates right Remarks: SLIGHT

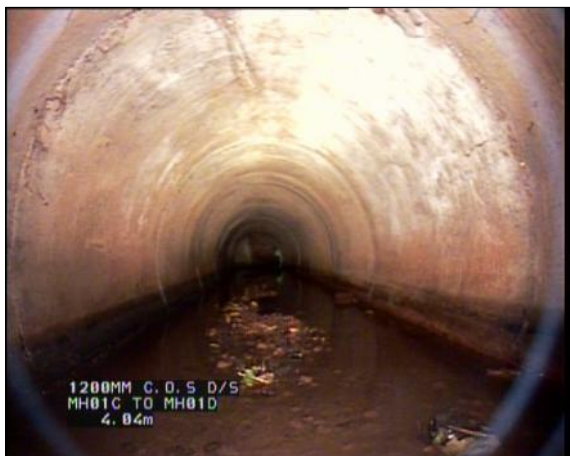
Photo: 26_26_288_A.jpg, 00:00:29
 2.4m, Settled deposits, fine, 20% cross-sectional area loss, Start

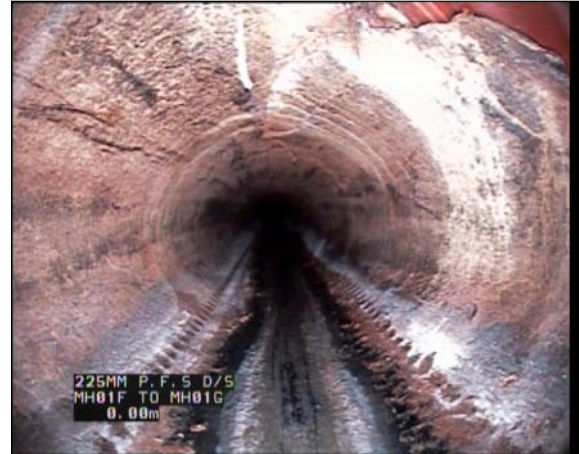
Photo: 1_1_10_A.jpg, 00:00:06
 0m, Attached deposits, grease, from 7 to 5 o'clock, 5% cross-sectional area loss
 Remarks: HEAVY FOUL POLLUTION THROUGHOUT

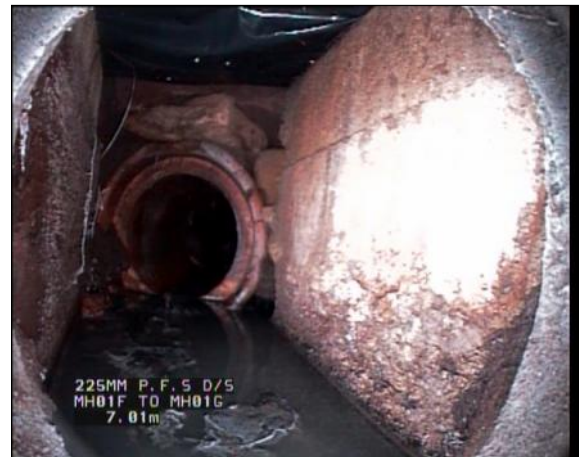
Photo: 29_29_313_A.jpg, 00:01:48
 7.1m, Finish node type, manhole reference number: 01G
 Remarks: BURIED MH01G TRACED & EXPOSED

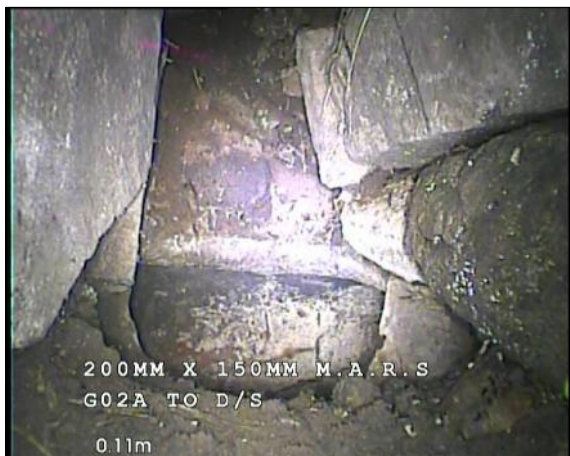
Photo: 30_30_320_A.jpg, 00:00:14
 0m, Displaced bricks, from 7 to 5 o'clock

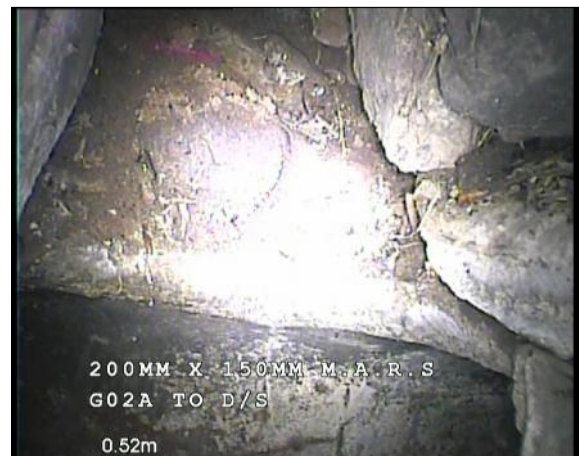
Photo: 30_30_322_A.jpg, 00:00:25
 0.5m, Line deviates right Remarks: CONNECTION ONTO
 MAIN 225MM CARRIER

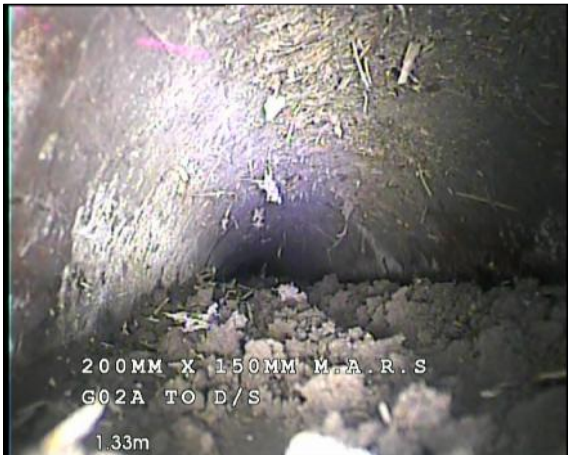
Photo: 30_30_327_A.jpg, 00:00:58
 1m, Settled deposits, fine, 75% cross-sectional area loss
 Remarks: HEAVILY SILTED MAIN CARRIER

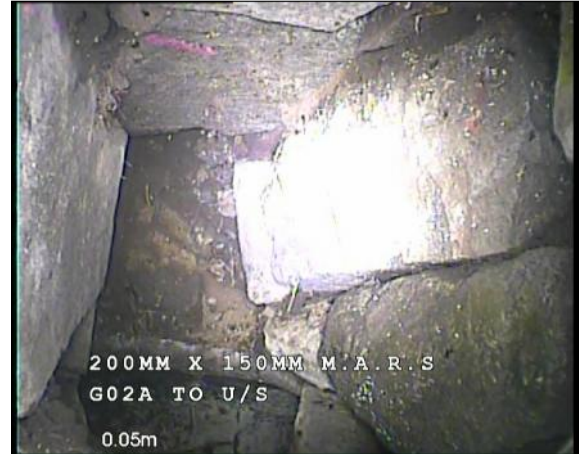
Photo: 31_31_332_A.jpg, 00:00:06
 0m, Displaced bricks, from 7 to 5 o'clock

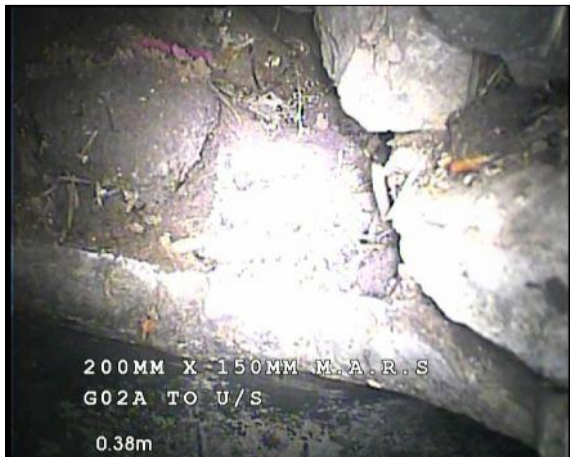
Photo: 31_31_334_A.jpg, 00:00:16
 0.5m, Line deviates left Remarks: CONNECTION ONTO MAIN 225MM CARRIER

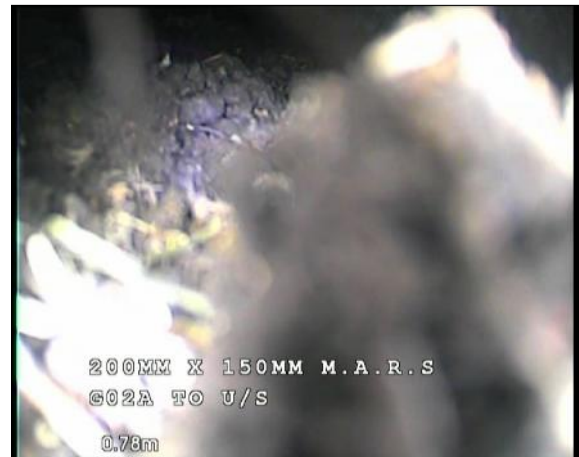
Photo: 31_31_338_A.jpg, 00:00:35
 0.8m, Survey abandoned Remarks: UNABLE TO PASS HEAVY SILT

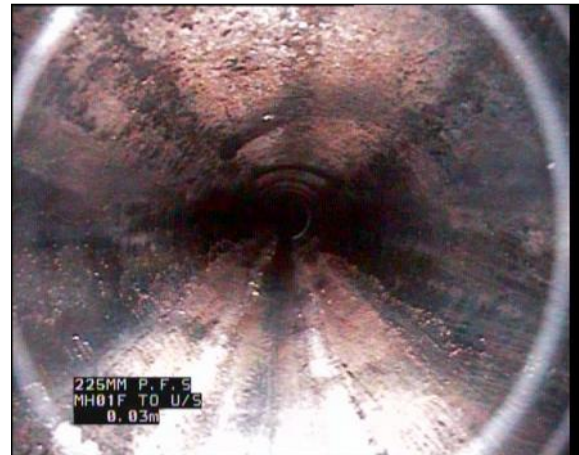
Photo: 32_32_341_A.jpg, 00:00:04
 0m, Attached deposits, grease, from 7 to 5 o'clock, 5%
 cross-sectional area loss, Start Remarks: HEAVY FOUL
 POLLUTION THROUGHOUT

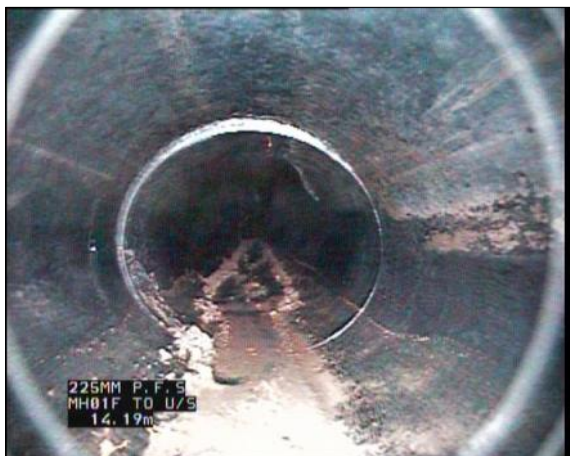
Photo: 32_32_346_A.jpg, 00:02:10
 14m, Deformed sewer/drain, 10%, Start

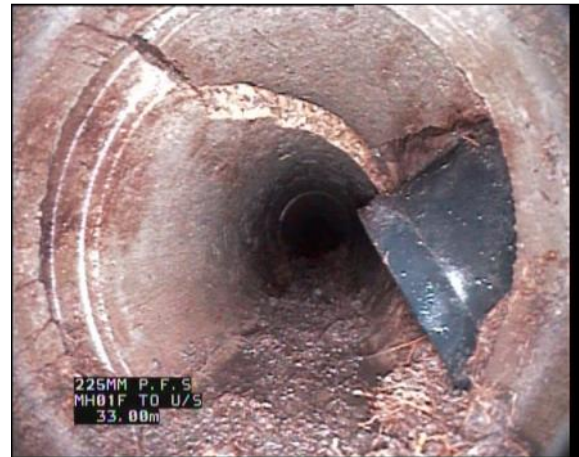
Photo: 32_32_362_A.jpg, 00:06:03
 33m, Connection intruding, at 3 o'clock, diameter 150mm, intrusion 10%

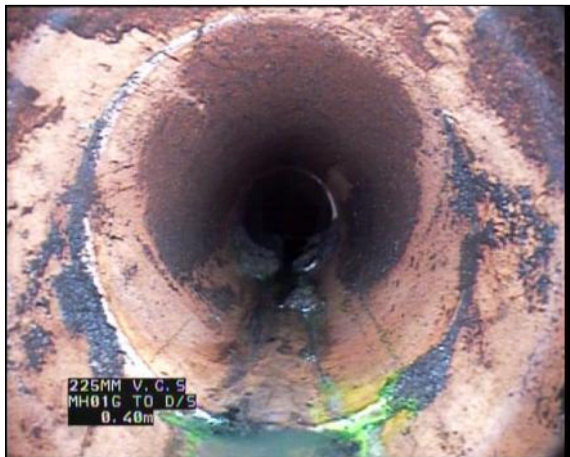
Photo: 33_33_369_A.jpg, 00:00:06
 0.4m, Roots, fine at joint, Start

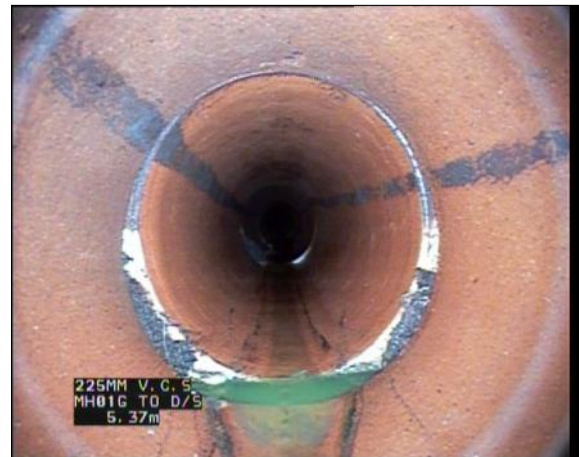
Photo: 33_33_371_A.jpg, 00:00:57
 5.3m, Joint displaced, medium

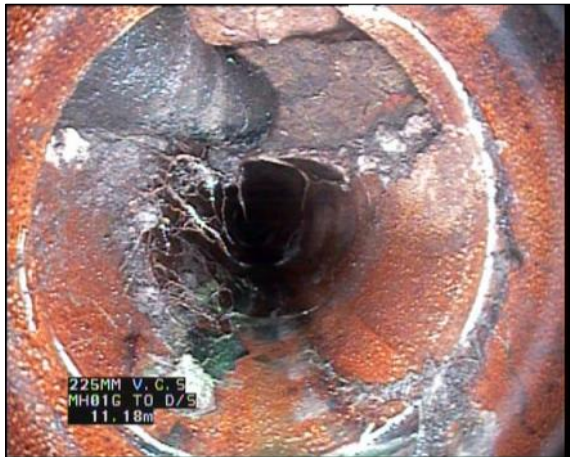
8.40	Joint displaced, medium		1
10.20	Crack, longitudinal, at 12 o'clock		2
11.10	Hole in drain/sewer, from 10 to 2 o'clock Remarks: LARGE HOLE	32_10A	5
13.20	Joint displaced, medium		1

Photo: 33_33_375_A.jpg, 00:01:45
 11.1m, Hole in drain/sewer, from 10 to 2 o'clock Remarks:
 LARGE HOLE

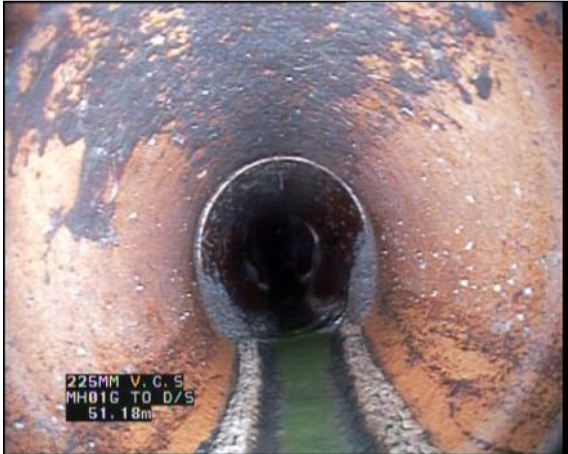
Photo: 33_33_392_A.jpg, 00:11:39
51m, Survey abandoned Remarks: UNABLE TO CONTINUE
DUE TO TRACTION/GREASE
