Project Name: AMEY 3076	Project number: 3076	Date: 05/08/2015	Contact: David Coombs, Amey
----------------------------	-------------------------	---------------------	--------------------------------

Place : BLAISDON, LONGHOPE	Road : BLAISDON VILLAGE ROAD	Date : 05/08/2015	Section number : 1	PLR Suffix : X
--------------------------------------	--	-----------------------------	------------------------------	--------------------------

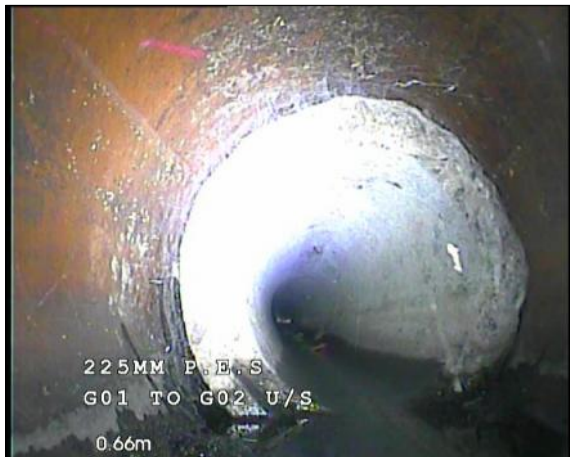
Photo: 3_3_38_A.jpg, 00:00:23
 0.7m, Dimension changes, 150mm high Remarks: POOR
 REDUCER

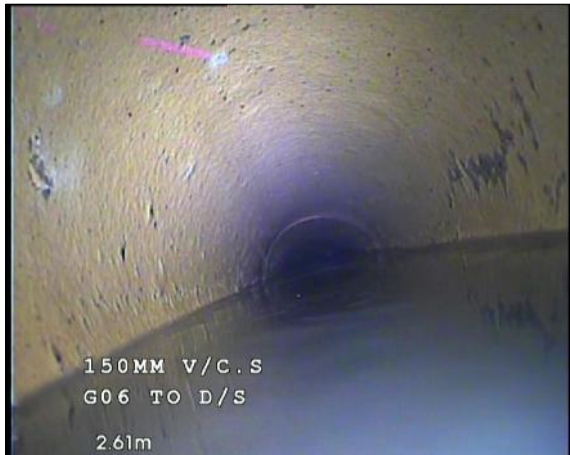
Photo: 6_6_69_A.jpg, 00:00:43
2.6m, Water level, 75% of the vertical dimension

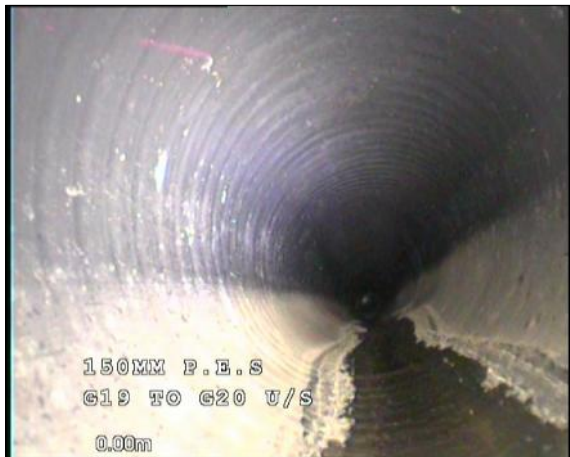
Photo: 20_20_237_A.jpg, 00:00:06
 0m, Water level, 05% of the vertical dimension

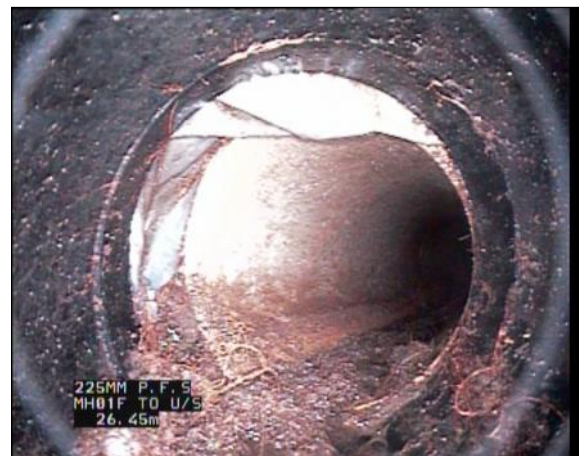
Photo: 32_32_352_A.jpg, 00:04:22
 26.4m, Line deviates right

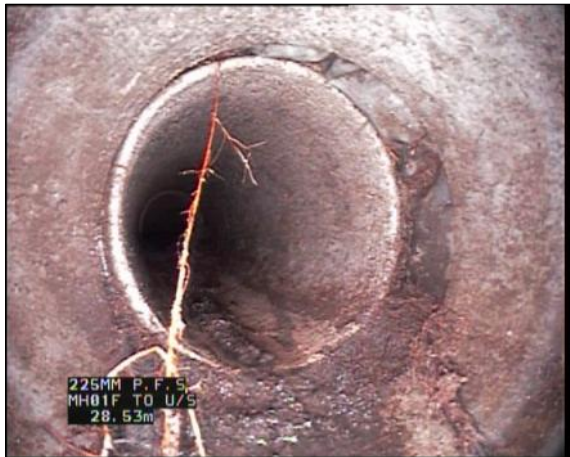
Photo: 32_32_356_A.jpg, 00:04:57
 28.5m, Line deviates left
